Crystalline waterproofing at hydro-electric power plant

Work to repair 2km of the main concrete tunnel at a hydropower plant in Italy centred on crystalline waterproofing. The system provides a permanent seal against water ingress and chemical attack and becomes an integral part of the concrete.

Florian Klouda, ICS/Penetron International Ltd, East Setauket, USA

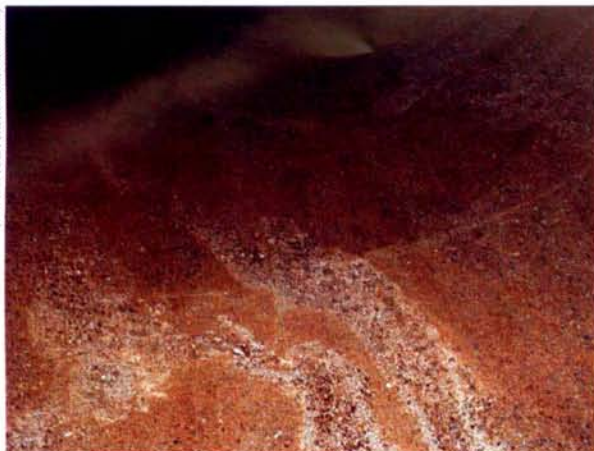
Figure 1: Tunnel surface after the cleaning operation and before the treatment.

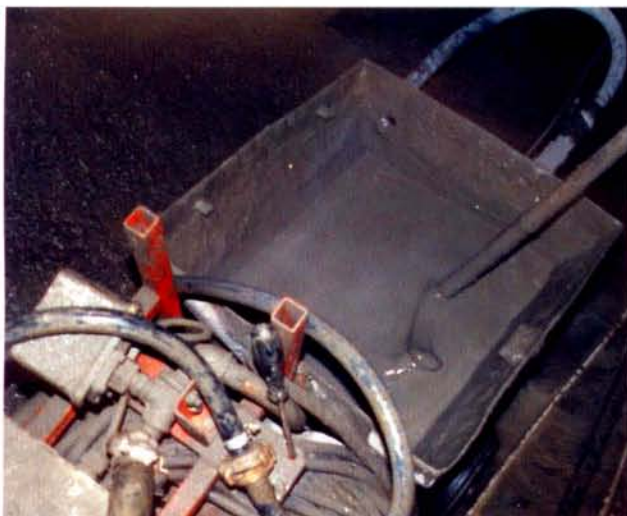
Figure 2: Mixed powder of crystalline product ready to apply in the spray machine tank.

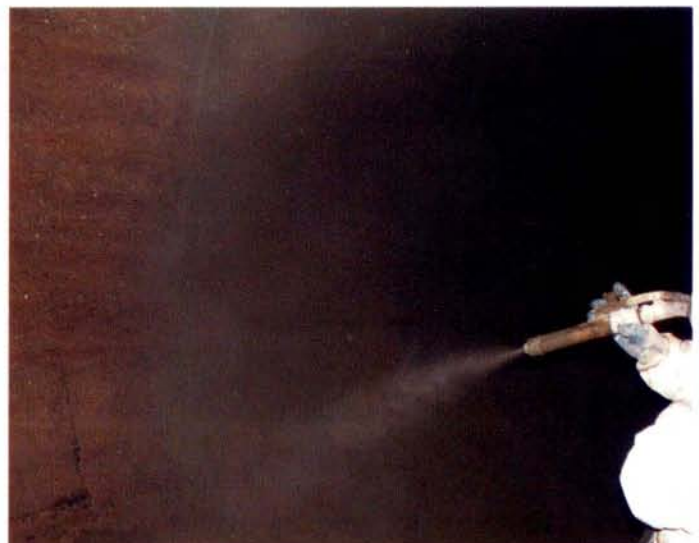
Figure 3: Spray-application of the slurry.

In order to waterproof the main tunnel of the Andonno hydro-electric power plant, all active leakage was stopped using resins before the crystalline waterproofing material was applied. All cracks larger than 0.4mm were cut out and chiselled back to a size of 30 x 30mm and were repaired with a crystalline-based mortar. Subsequently, the entire levelled concrete surface of the tunnel section to be repaired (24,000m²) was water-blasted under high pressure to open up the capillary system of the concrete and an additional two coats of crystalline waterproofing were spray-applied at a rate of 0.8kg/m² for each coat.

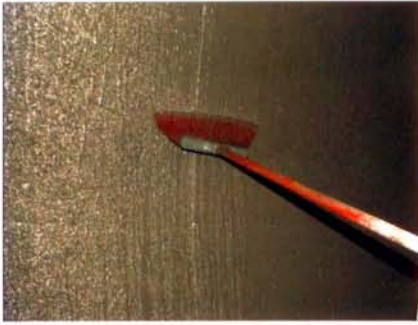
Figure 4 above: Brush distribution of excess material between the two coats.

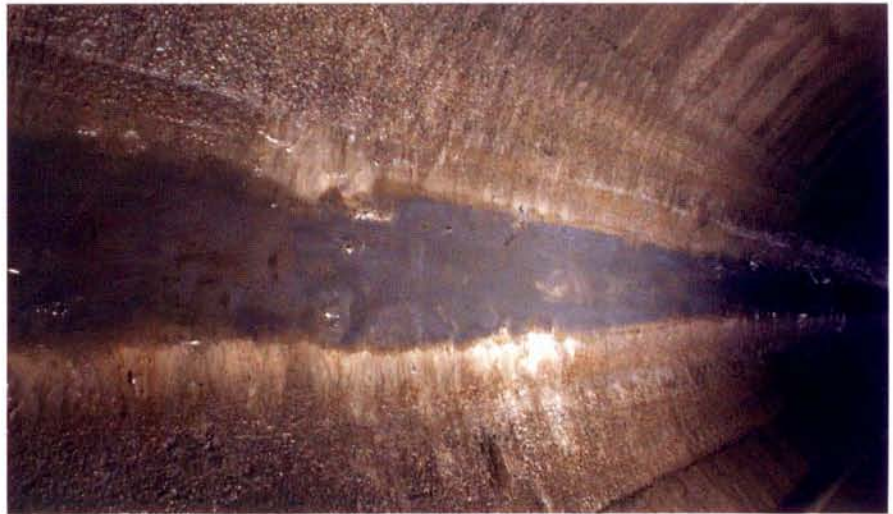
Figure 5 right: Repaired horizontal cracks.

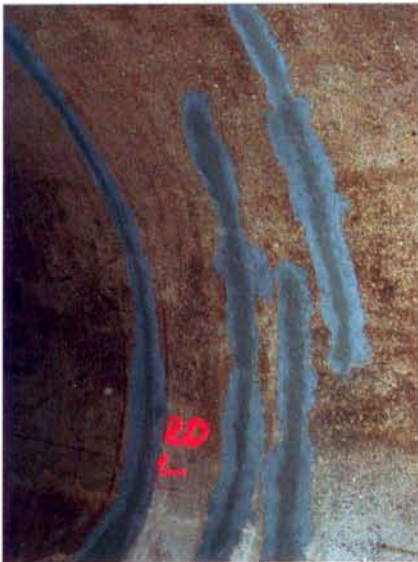
Figure 6: Repaired tunnel construction joints.

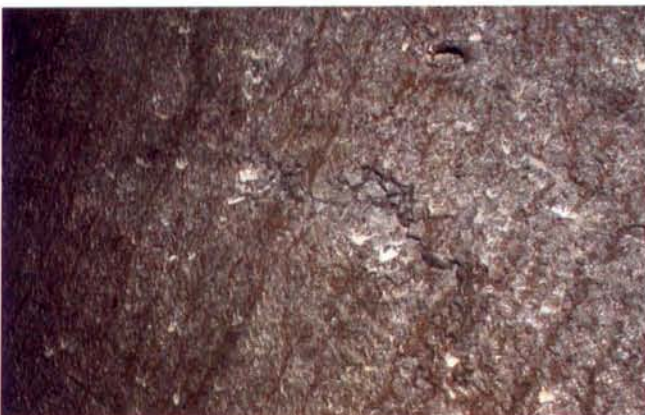
Figure 7: Crystalline waterproofed surface after one week of curing.

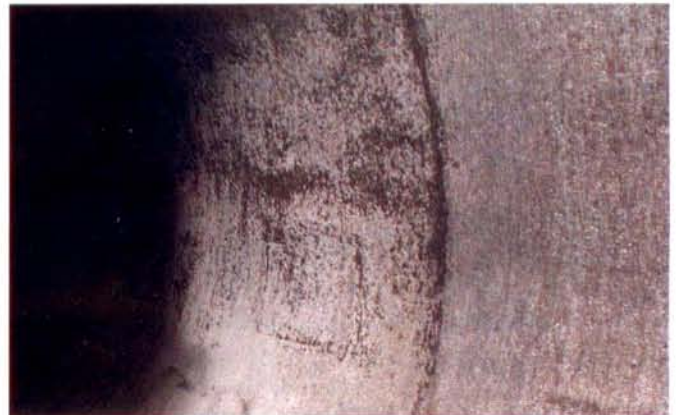
Figure 8: Treated tunnel wall after one week of curing.
